LTPP Seasonal Monitoring Program

Site Installation and Initial Data Collection
Section 100102, Ellendale, Delaware

Report No. FHWA-TS-96-10-02

June 1996

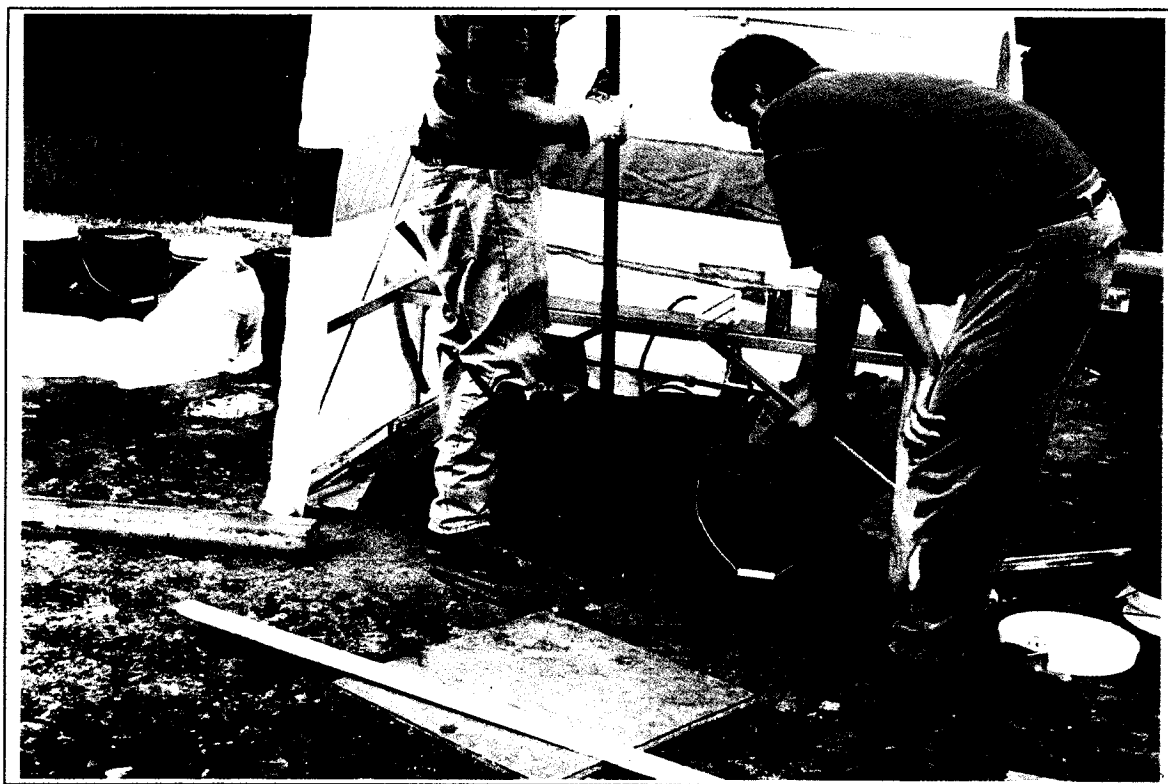
Figure E-9. Backfilling and Compacting the Instrument Hole

To check for breakage of the TDR probes during installation, each probe was connected to the cable tester and its wave form monitored during compaction of the material around it. The TDR traces are included in Appendix C. The cables coming from the TDR probes were staggered along the perimeter of the instrument hole to prevent water from migrating along a bundle of cables. The top TDR probe was placed with the printed circuit board and the cable facing downward to avoid any contact with the asphalt concrete pavement surface. The top of the thermistor probe was 0.133 m below the pavement surface. The cables from all instrumentation installed converged at the opening of the flexible conduit pipe which was placed about 50 mm from the edge of the core hole. The cables were then tie wrapped in two bundles and passed through the conduits to the equipment cabinet. The ends of the conduits were plugged with a mastic pipe sealant.

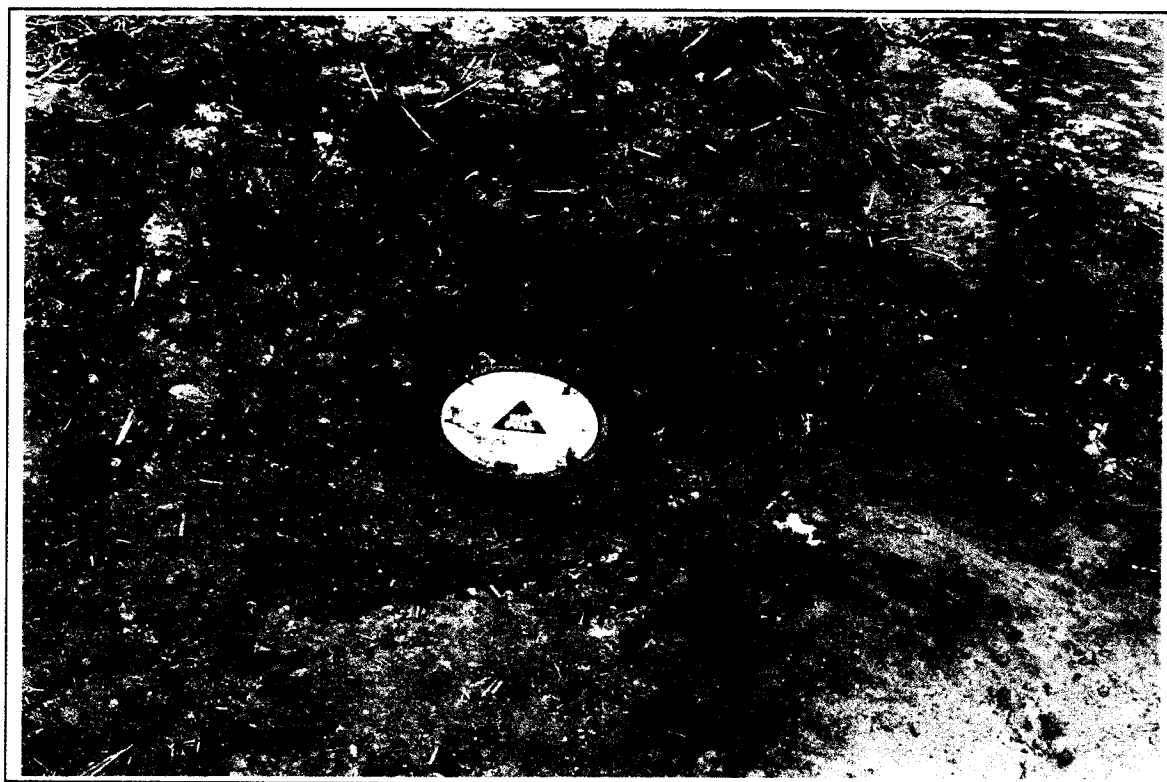
Figure E-10. Completed Piezometer

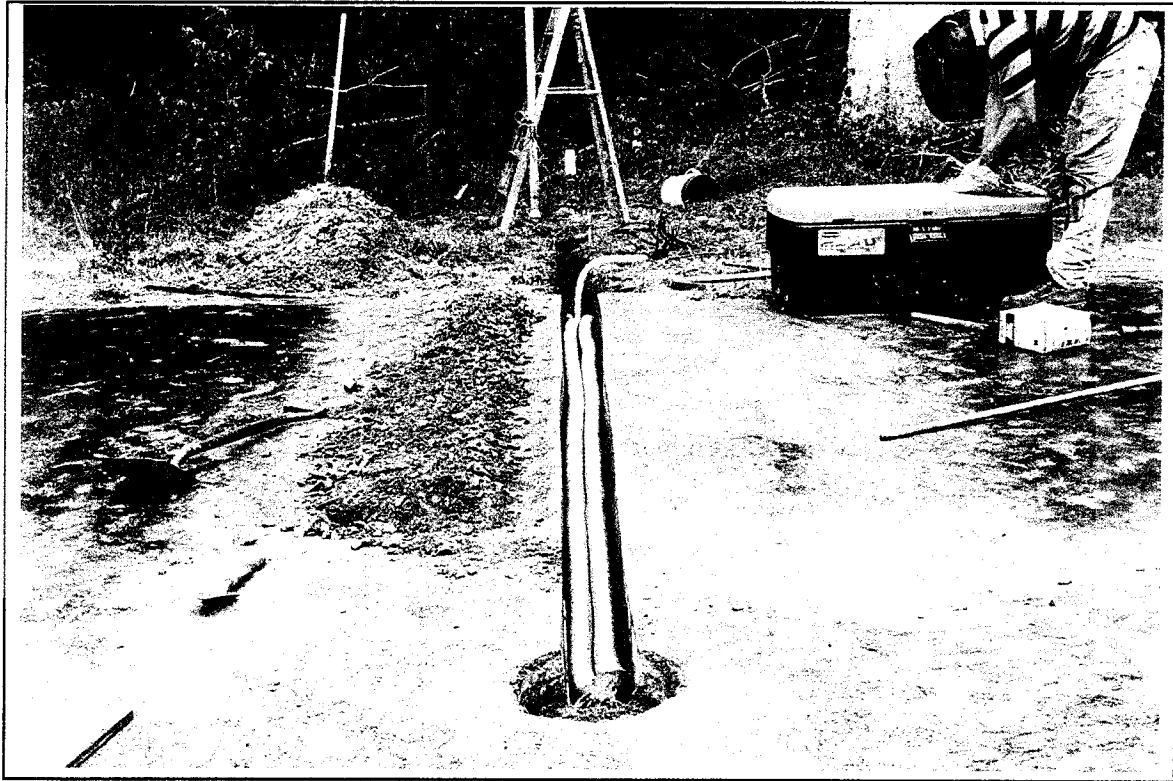
Figure E-13. Cabling Conduits in the Trench

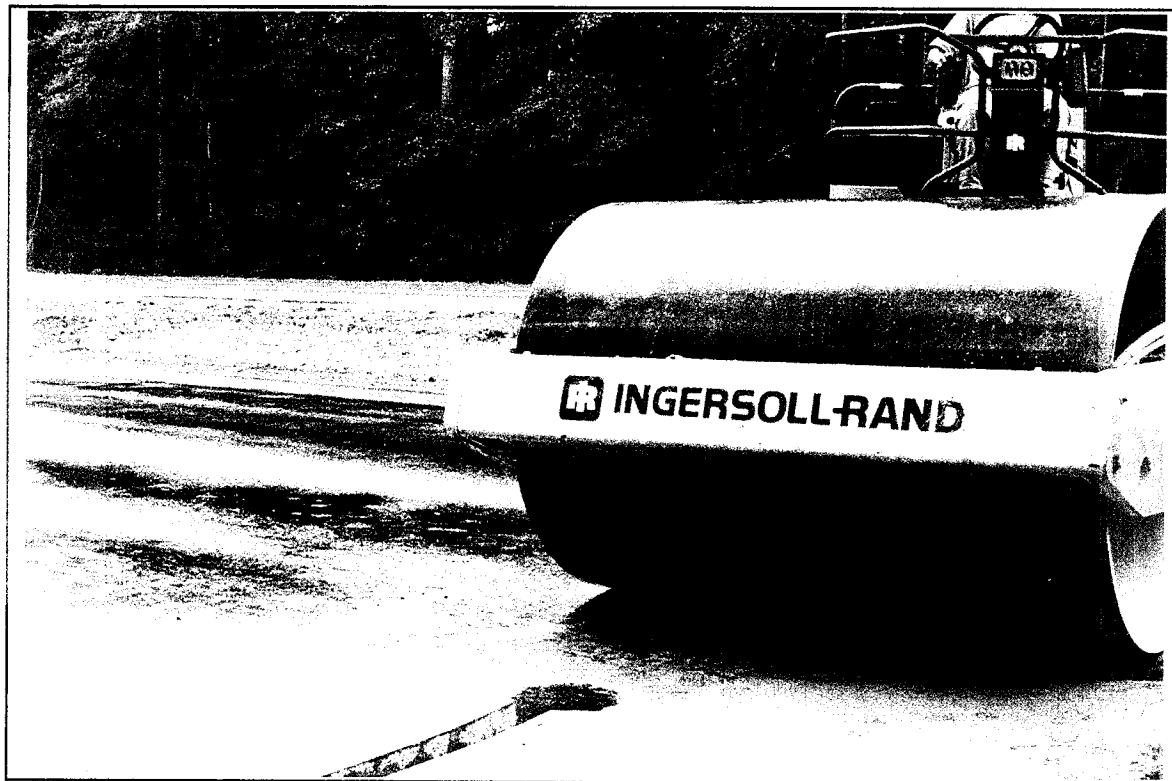
Figure E-14. Vibratory Compaction of the Instrument Hole

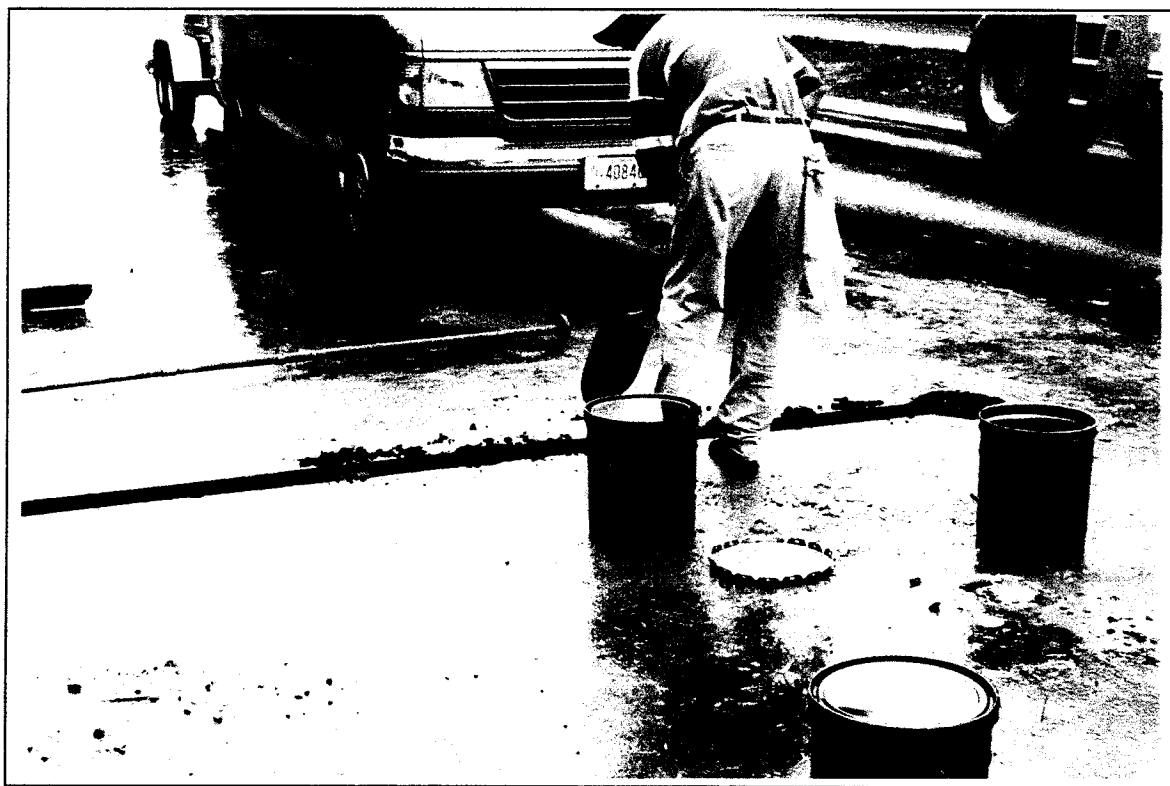
Figure E-15. Placing Asphalt in Trench

The instrumentation hole and trench were repaired by placing and compacting hot mix asphalt concrete. The contractor, Greggo and Ferrara, filled and compacted the hot-mix after completion of the installation. There was not enough asphalt concrete to complete the trench. Arrangements were made for DEL DOT to complete the filling of the trench and remove all the chunks of asphalt material removed from the pavement. A vibratory compactor was used to compact the asphalt concrete. Soil cover of at least 50 mm was maintained over the conduit for the extent of the paved trench. The road base material removed from the trench was used to bring it up to grade.

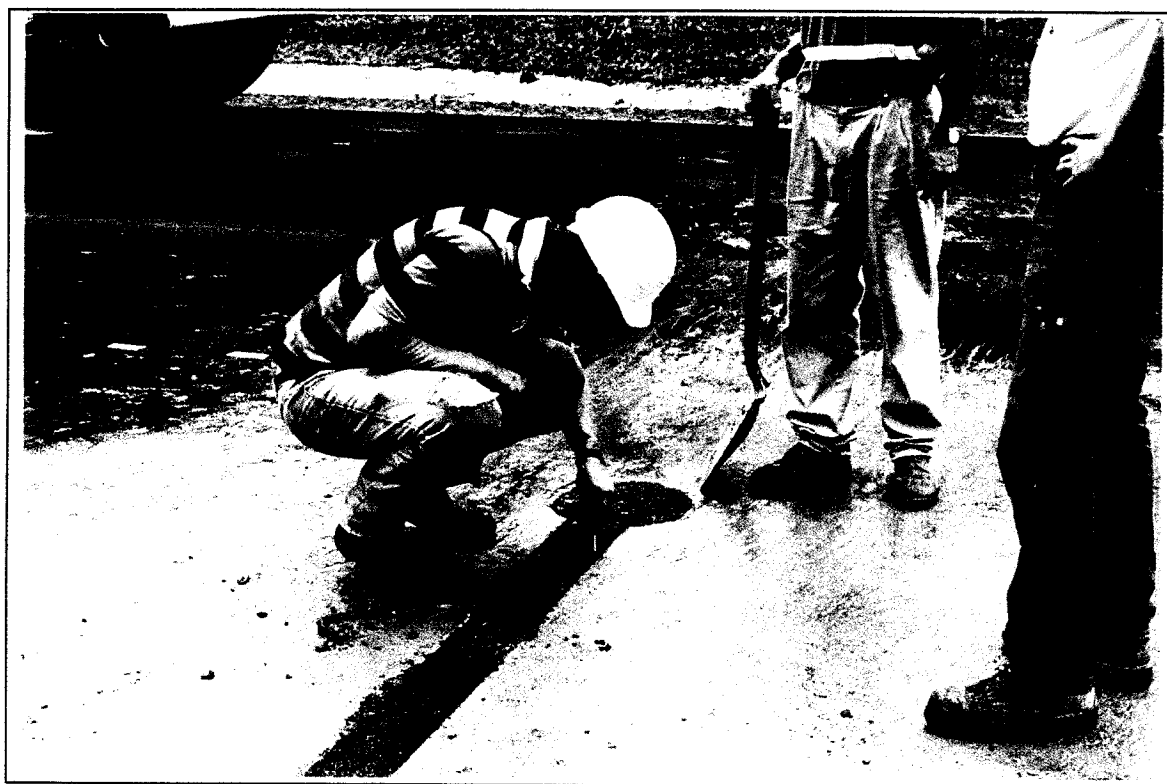
Figure E-16. Checking Top of MRC Probe
